LISTER LH150 GEARBOX ADJUSTMENT

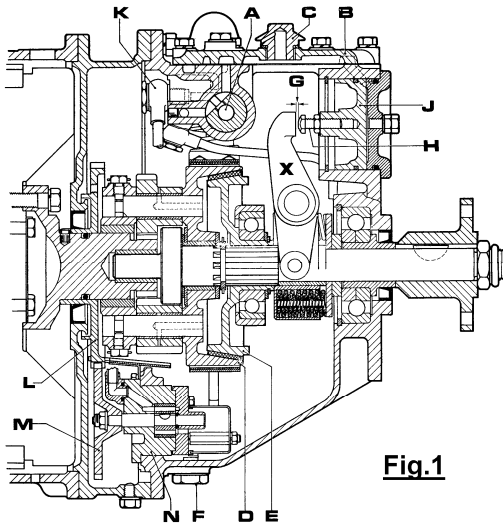
Fig.1

This is especially important with regard to the clearance on the forward drive extraction linkage (dimension "G" on fig.1) since the action of the gearbox is that the forward drive cone is held in engagement with the clutch body by a spring pack and it is only disengagement that is effected by hydraulic pressure. If the clearance at "G" is not present there is a probability that the drive cone may be held slightly out of engagement causing slip and excessive wear to the clutch lining.

A clearance at "G" may be verified by removing the filler cap "C" and inserting a screwdriver between the bolt "H" and the operating lever "X".

With the aid of a torch it is then possible to determine whether a clearance exists.

If this is not the case, the gearbox top cover must be removed for necessary adjustment to be made to the recommended value of $\frac{3}{32}$ " (2.38mm).

To adjust – using $\frac{3}{4}$ " a/f spanner to prevent piston "J" from rotating, loosen lock-nut ($\frac{1}{2}$ " a/f) on bolt "J". Ensuring that piston is pushed fully to rear of box, adjust position of this bolt to give recommended clearance and lock in position with nut.

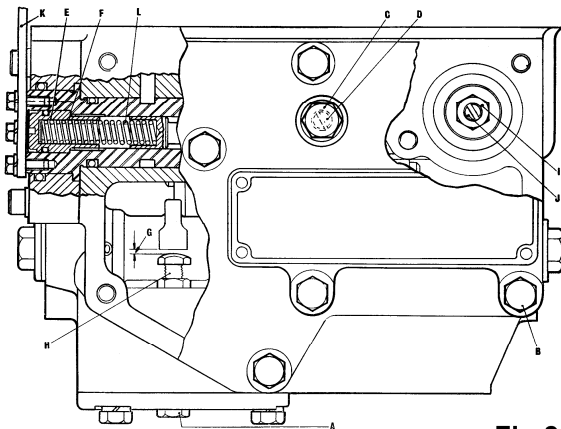
Fig.2 shows the Reverse band operating spindle "J" and lock-nut "I", visible when gearbox cover is removed.

Hold the slotted end of the spindle in position with a screwdriver and using a $\frac{1}{2}$ " a/f spanner, tighten the lock-nut until the band securely grips the clutch body.

Following adjustment the gearbox top cover may be replaced. If the existing gasket shows evidence of damage a new joint should be fitted and surfaces smeared with grease on assembly.
